Technical Bulletin

MOTORCYCLE SAE 2483 no. M83-005

SR/TT/XT250

Crankshaft oil-Gallery Modification

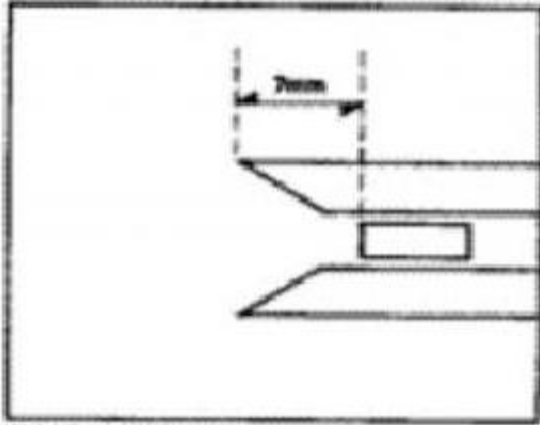
ILLUSTRATION 1

The action of the crankshaft on some affected models may act as a centrifugal pump, drawing too much oil; this means there is less oil available for delivery to the top end. Installation of a special roll pin in the crankshaft will correct this. The crankshaft oil gallery will be partially restricted; reducing the drawing action of the crankshaft so more oil will be available for delivery to the top end. **This modification will not adversely affect the lubrication of the crankshaft; the crankshaft will be adequately lubricated.**

2. Drain the oil from the motorcycle, remove the kick starter and remove the right-hand side cover.
3. With a properly sized punch, drive the roll pin into the crankshaft oil gallery as shown in illustration 1. The pin should be 7mm from the end of the crankshaft.
4. Inspect the crankshaft oil seal in the right-hand crankcase cover: see illustration 2. If the seal is work, damaged, or cooked in its place, replace or reposition it. **This oil seal much be inspected.** The engine will be severely damaged if the seal is worn, damaged or improperly positioned.

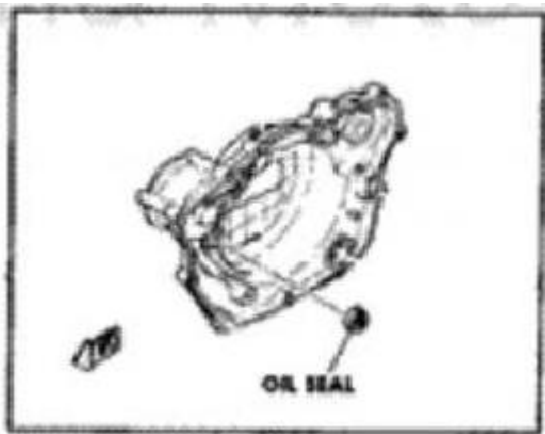
ILLUSTRATION 2

4. Inspect the crankshaft oil seal in the right-hand crankcase cover; see Illustration 2. If the seal is worn, damaged, or cocked in its boss, replace or reposition it. **This oil seal must be inspected; the engine will be severely damaged if it is worn, damaged, or improperly positioned.**
